Confirmed Tornado
Queensville, Ontario
July 15, 1977

Tornado F-Scale Assessment

QUEENSVILLE TORNADO OBSERVATIONS by P Elms.

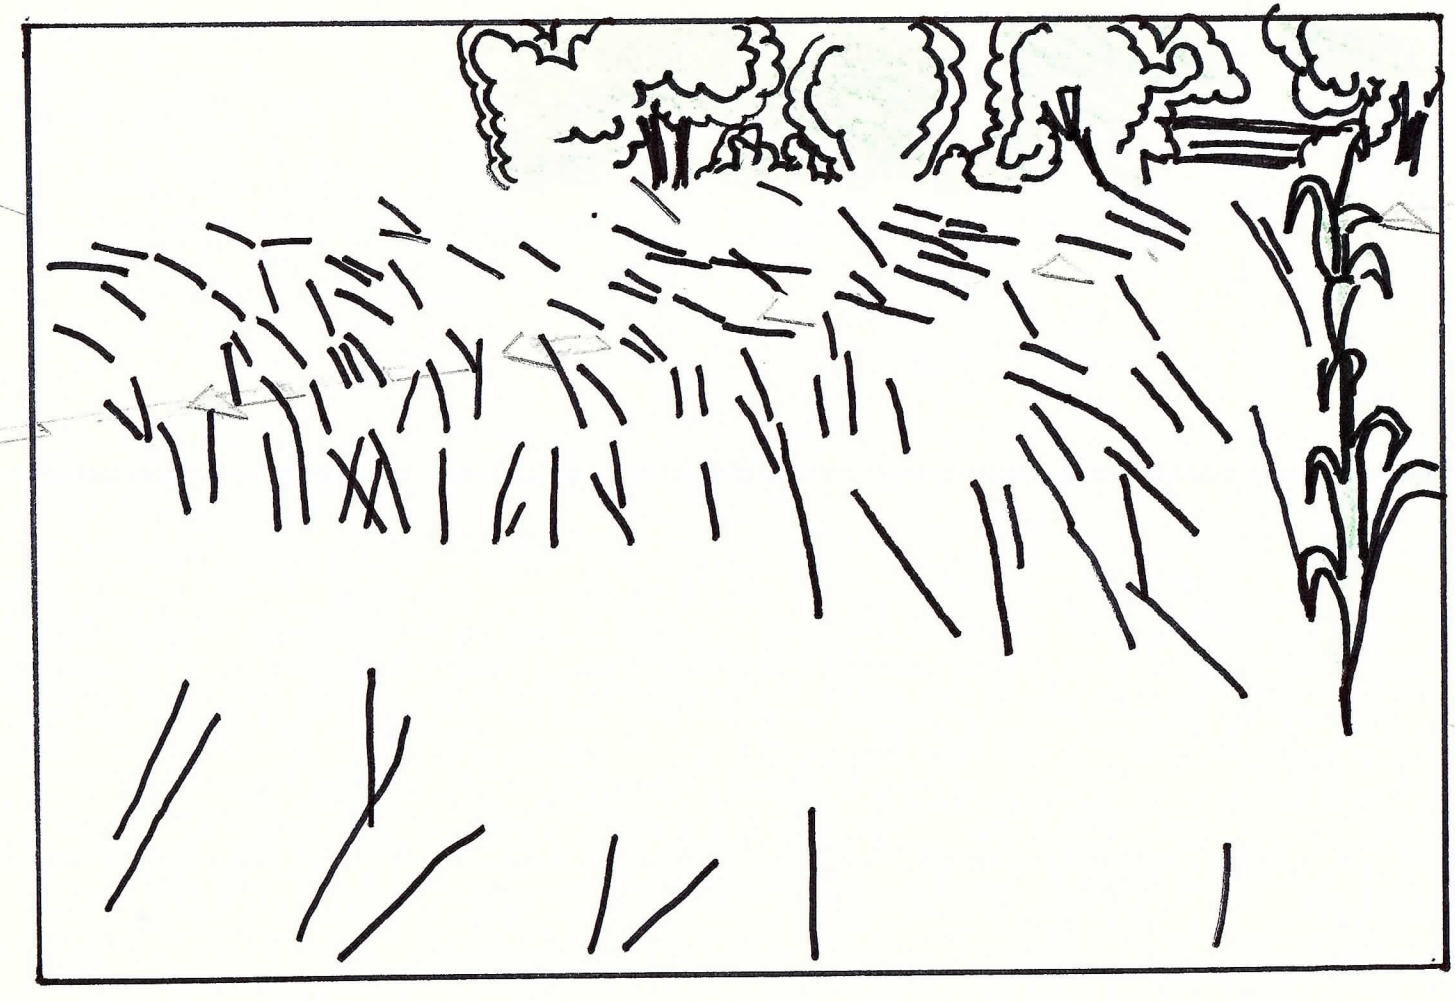
CORNSTALKS FLATTENED AND SWIRLED IN FIELD WEST OF LUNDY FARM
(FROM A SLIDE)
by M.J Newark
