B PHOTOS OF WRECKED SAWMILL. F=0

TORNADO PROJECT SUMMARY SHEET

1. DATE AND TIME SUN. MAY 13 1956. ABOUT 2330 E.S.T

2. LOCATION OR PATH (attach map) SSW TO NNE, TOBERMORY ONT.

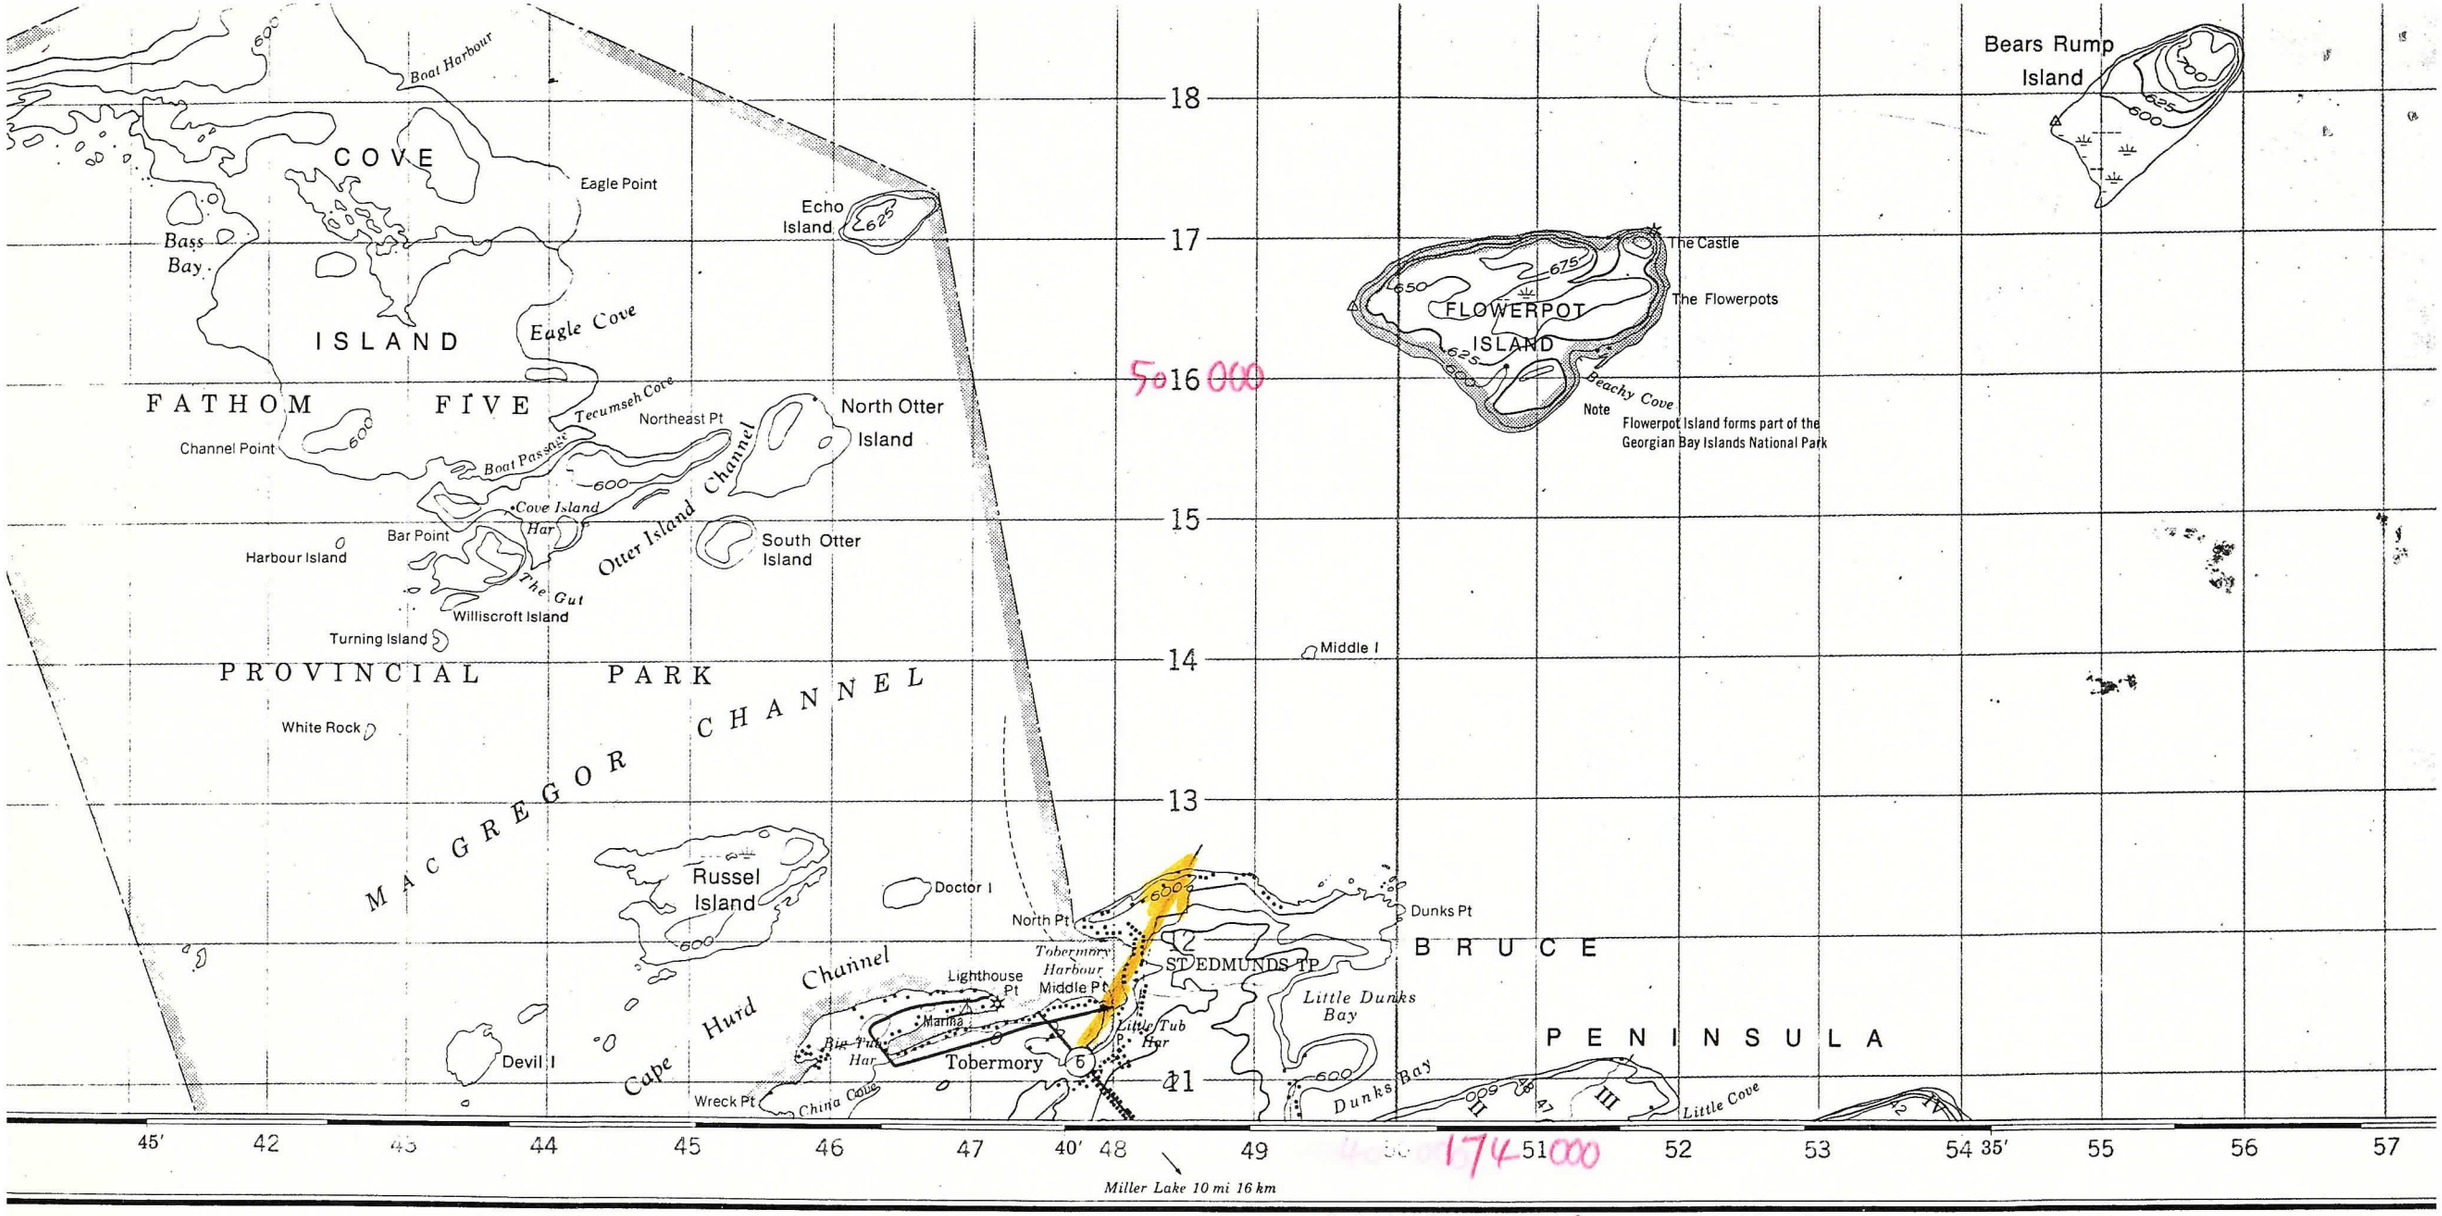
APPARENTLY BEGAN AT THE FERRY DOCK, THEN CROSSED THE NARROW CHANNEL AND STRUCK THE FAR SHORE.
SMALL BUILDINGS, SIGNS, A SHIP'S GANGWAY DAMAGE AT THE BEGINNING OF THE TRACK. AFTER CROSSING THE CHANNEL IT LIFTED A BOAT, THAT WAS ON SHORE, AND TURNED IT COMPLETELY AROUND (CABIN CRUISER?). NEXT, ERBS SAWMILL WAS COMPLETELY DESTROYED, ONLY THE FOUNDATION REMAING. THE ROOF WAS BLOWN INTO THE CHANNEL ABOUT 100 AWAY. THIS BUILDING WAS OF SQUARED TIMBER CONSTRUCTION LIKE A BARN - VERY SUBSTANTIAL.
TREES WERE TWISTED OFF, FENCES BLOWN DOWN, A TELEVISION AMTENNA WRECKED
WINDOWS WERE TAKEN OUT OF THE ERB' HOUSE ALSO A 2"X4" WENT THROUGH A HOUSE WINDOW.
ONE CABIN WAS UPSET AND ANOTHER SMASHED.

In its course the twister attended the old BUCKEYE FISH SHED near the FERRY DOCK and carried off part of the HANDICRAFTS STORE SIGN. It whisked away the "NORISLES" gangways and across the harbour, at LEE BROS. NET SHED, it took the roof off. It completely demolished E.A.ERB'S large SAWMILL, leaving only the foundation and smashed one of MRS. J.A.CRAIGIE'S CABINS and upset another.

THE SAWMILL roof finished up floating in the lake
